XP-8X4X-Atom CE6 OS Release Note,

Version 1.4.0.0 [Sep., 22, 2014]

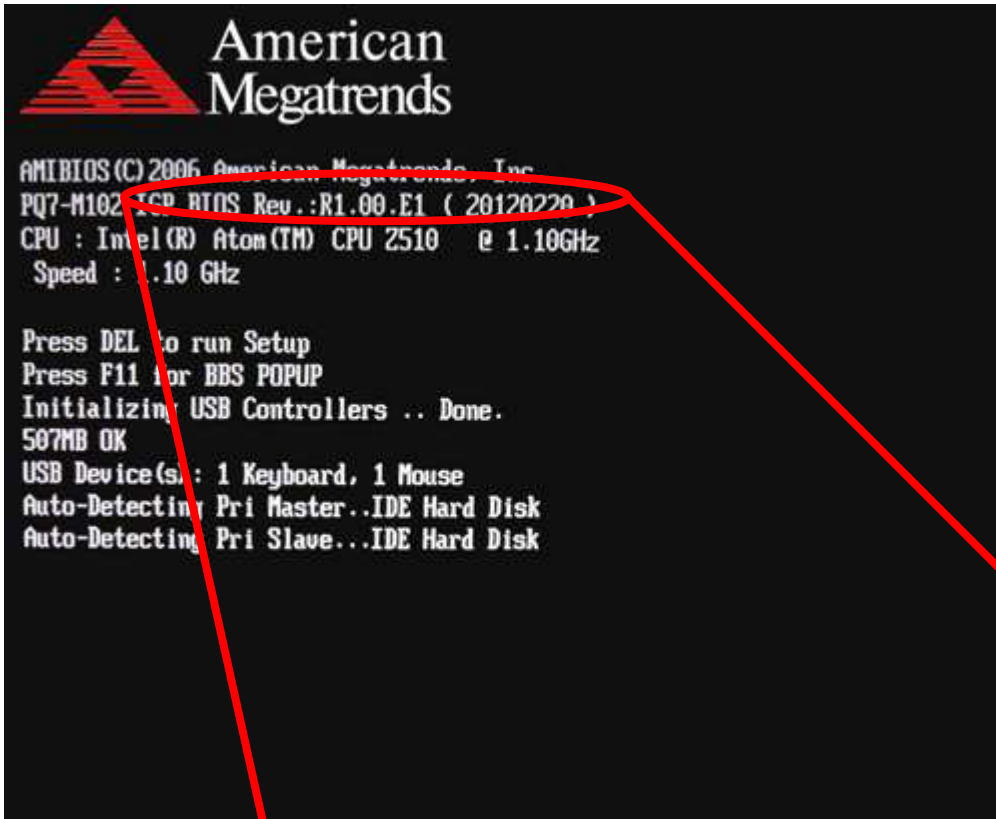
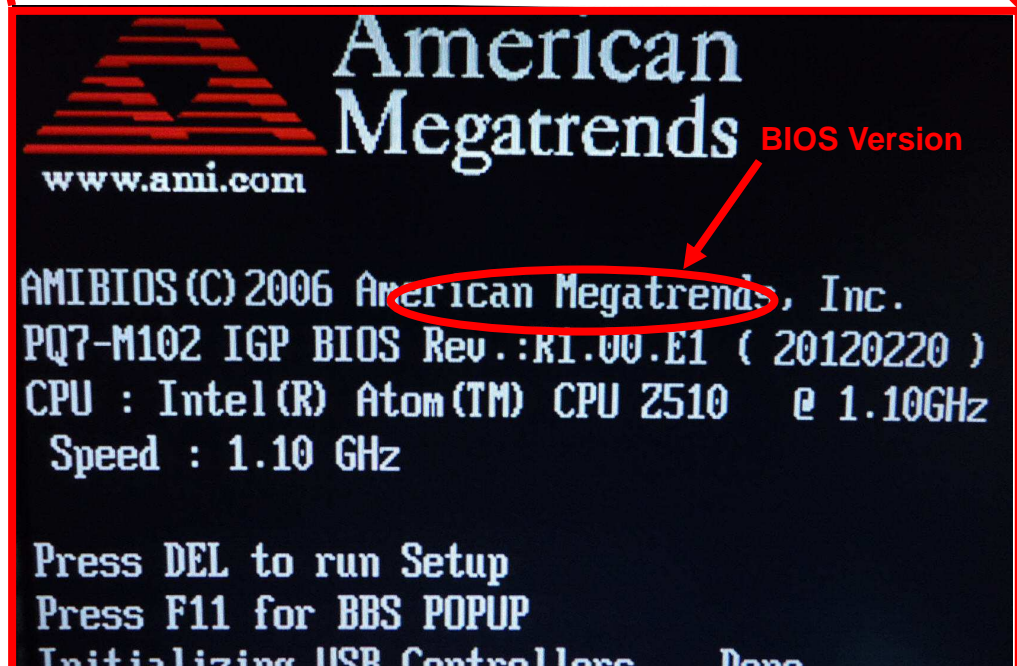
1. Power on the XP-8000-Atom-CE6 and press the "Pause Break" key on your PC keyboard to suspend the boot process.
2. Identify the version as shown below:
