DCON Utility revision history

DCON Utility Version 5.2.0
Release Date May 30 2011

[Version 5.2.0 Beta 1] [Jan 15 2011]

[Version 5.1.9] [Sep,30,2010]

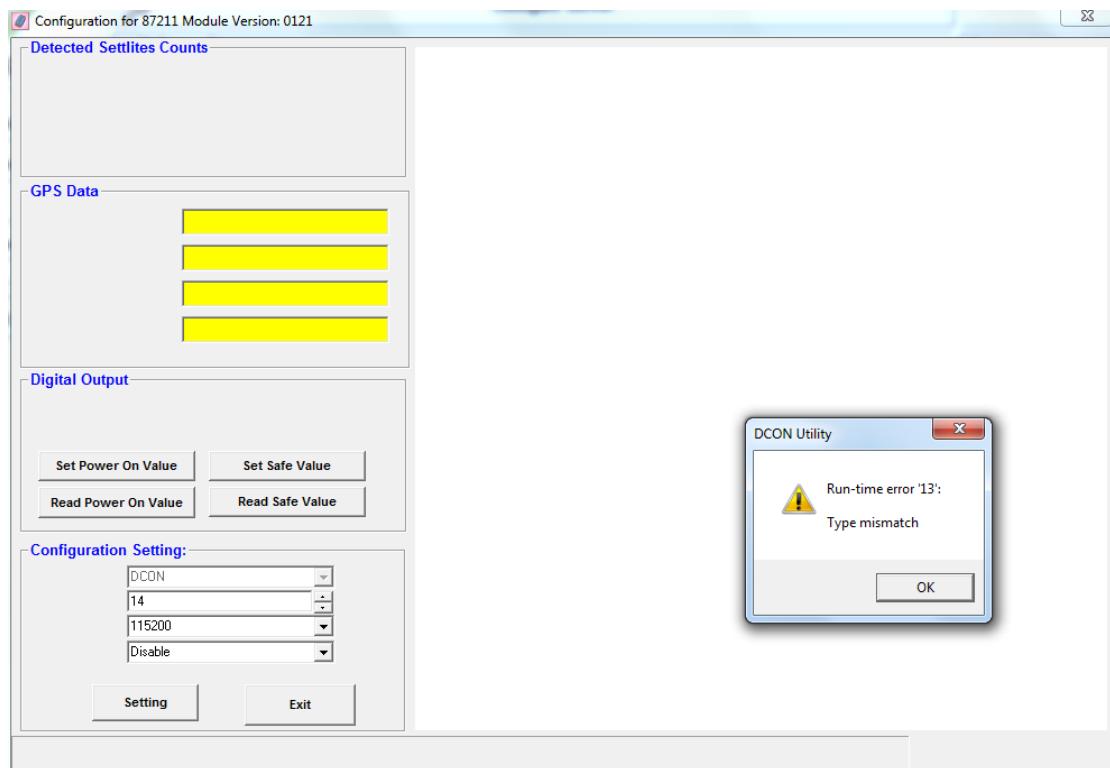
1. Click I-87211W form to cause “Run-time error 13” as below:

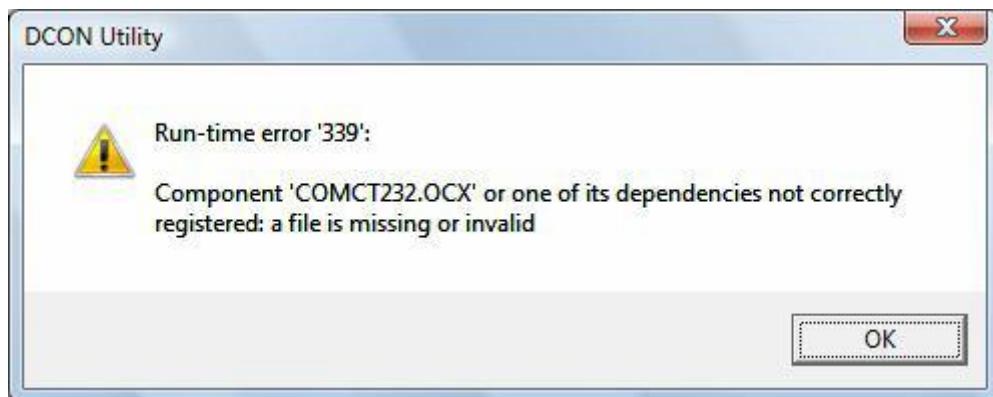
2. Add manifest function to avoid abnormal install and run DCON Utility in Windows 7 and Vista , or it will cause ocx file fault (similar “Run-time error 339” as below). We recommend to install and run it using administrator account. If it appears , please refer FAQ_Run_time_error.pdf to solve it

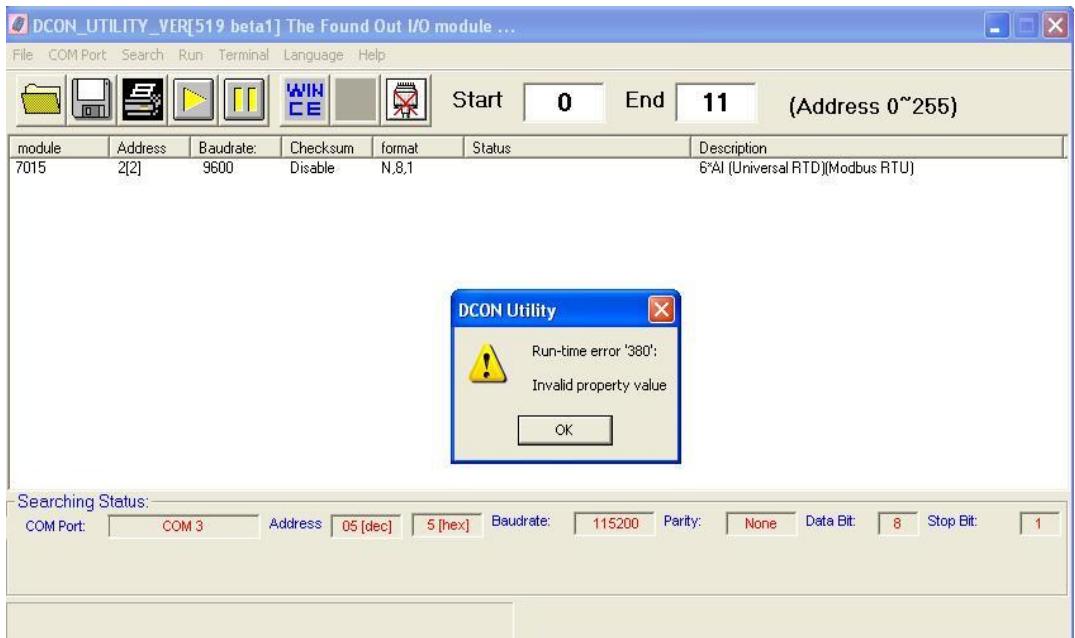
3. Click old M-7015 firmware version (Before version B202) to cause “Run-time error 380” as below

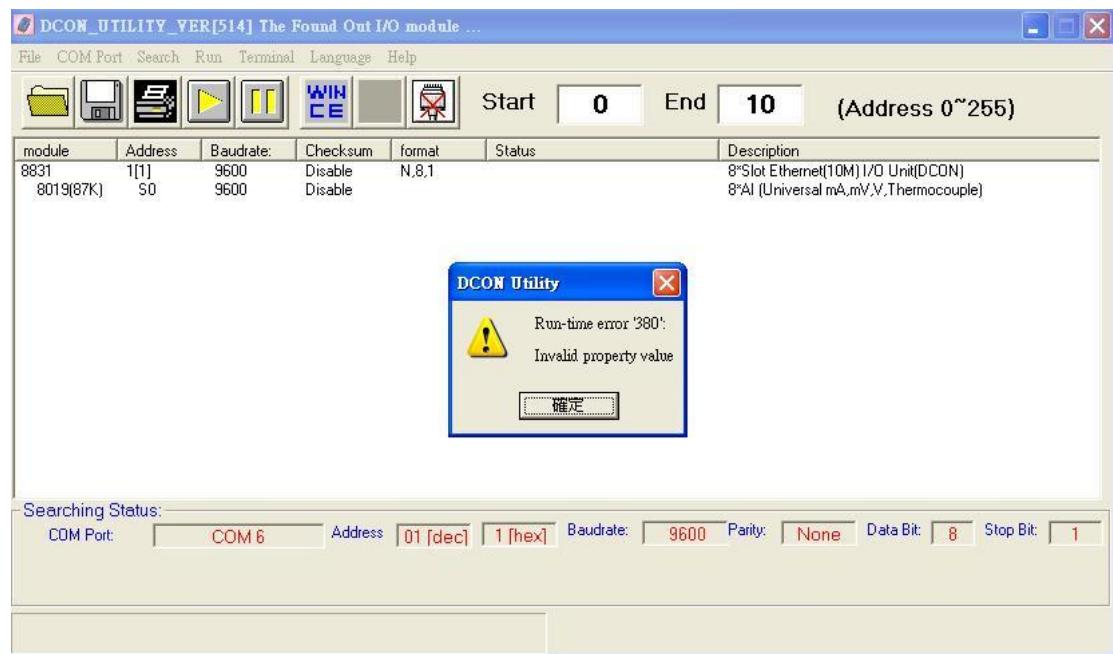
- When using DCON firmware ,click 8019(87K) to cause “Run-time error 380” as below

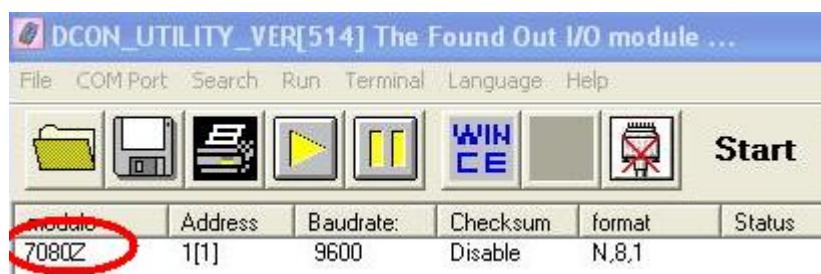
1. When DCON Utility searches M-7080BD ,it shows "7080Z"

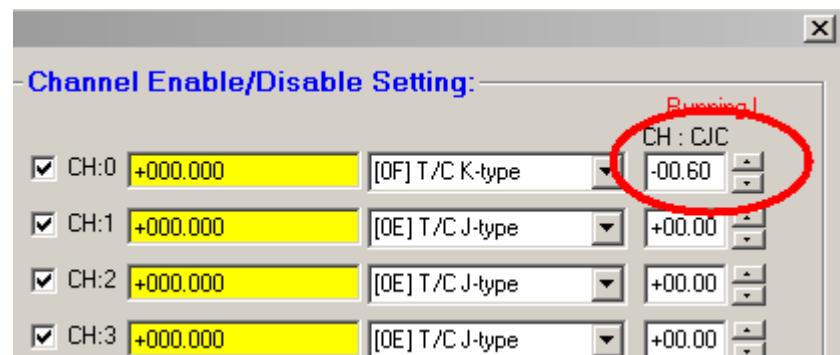
2. M-7018 can't set channel CJC function

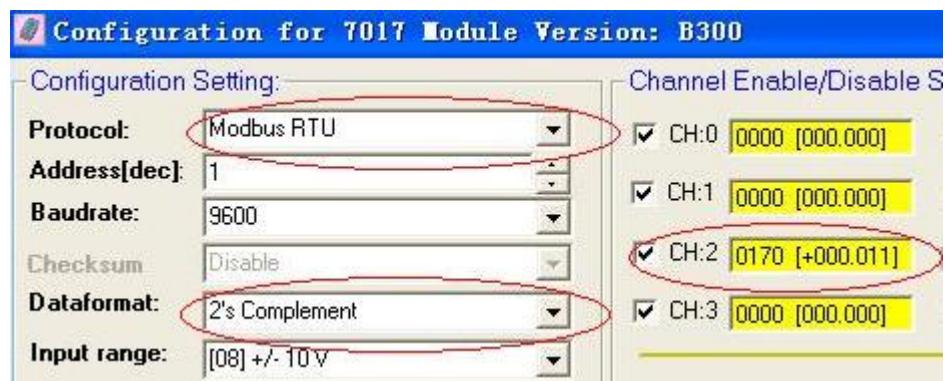
3. I-7017 and M-7017 show wrong AI value in Hex data format
