DCON Utility revision history

DCON Utility Version 5.1.7
Release Date Feb 11 2010

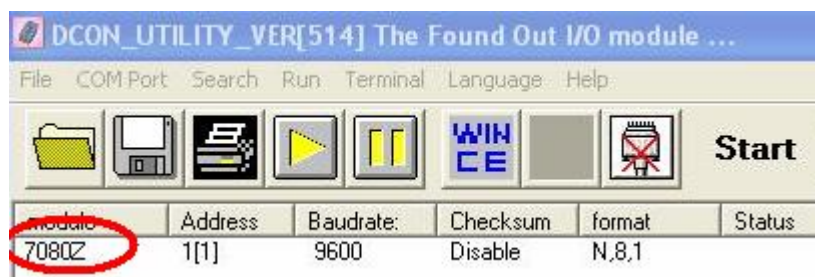
1. When DCON Utility searches M-7080BD ,it shows "7080Z"

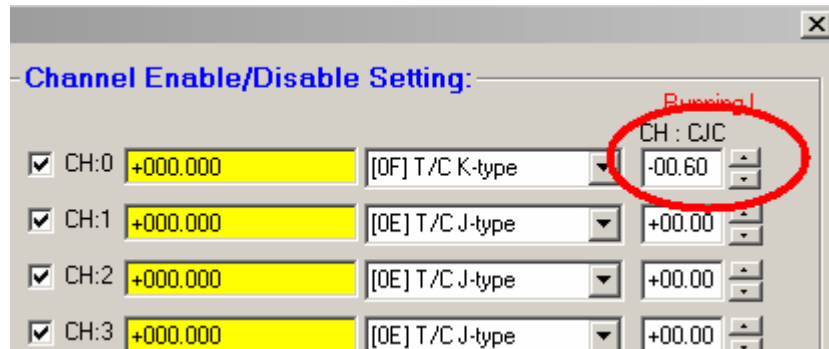
2. M-7018 can't set channel CJC function

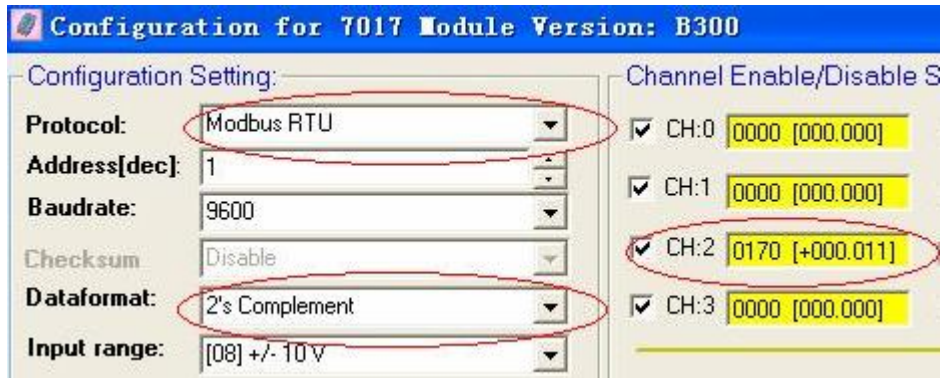
3. I-7017 and M-7017 show wrong AI value in Hex data format
