# XP-8X4X-Atom CE6 OS Release Note,

## Version 1.0.0.2 [Apr., 09, 2012]

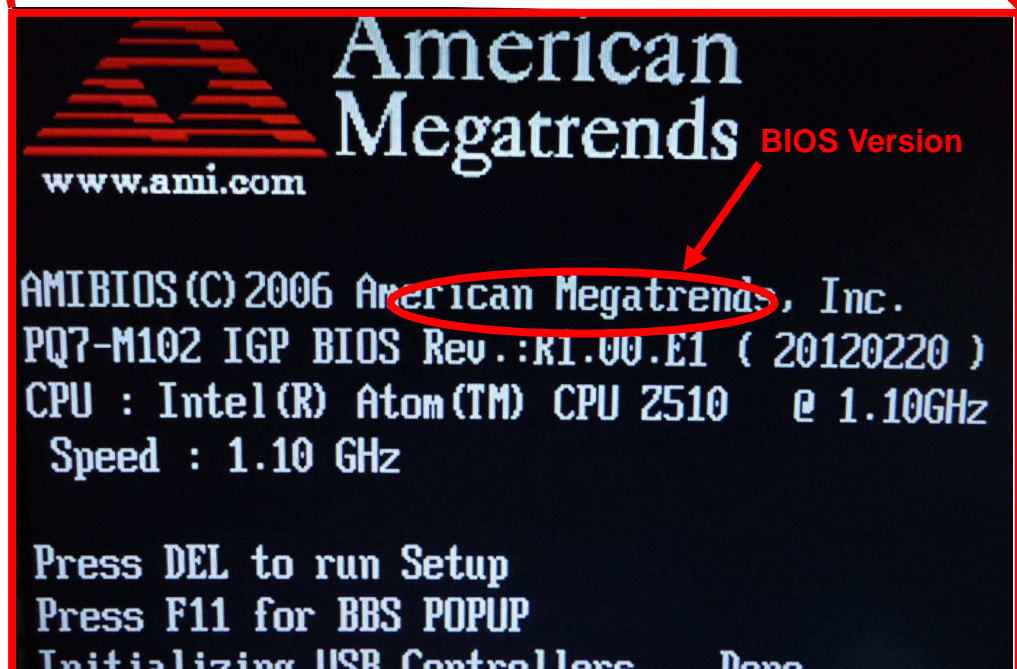
1. Power on the XP-8000-Atom-CE6 and press the "Pause Break" key on your PC keyboard to suspend the boot process.
2. Identify the version as shown below:

\* See page 3 for details of how to determine the current version of the BIOS on your controller

The latest version of the OS fixes an issue when the interrupt retrigger function caused an error in the I-8K module and another issue that caused the registry to be restored to the factory default settings. Note that OS version 1.2.0.0 requires BIOS version R1.00.E1 or later. The BIOS version can be determined from the display during the initial boot up, as described on page 3.
