XP-8X4X-Atom-CE6 OS Version 1.2.0.0

Release Notes

Release Date: May 21, 2013

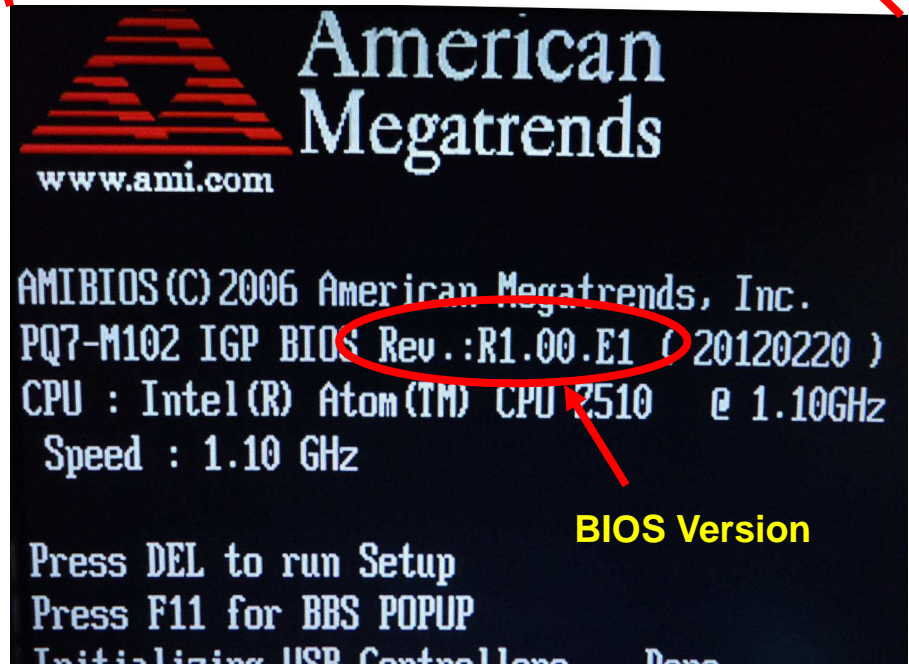
1. Power on the XP-8000-Atom-CE6 module, and then press the "Pause Break" key to suspend the boot process.
2. Determine the BIOS version, as shown below:

The latest version of the OS fixes an issue when the interrupt retrigger function caused an error in the I-8K module and another issue that caused the registry to be restored to the factory default settings. Note that OS version 1.2.0.0 requires BIOS version R1.00.E1 or later. The BIOS version can be determined from the display during the initial boot up, as described on page 4.
