WP-8x3x Release Note

Hardware Revision:

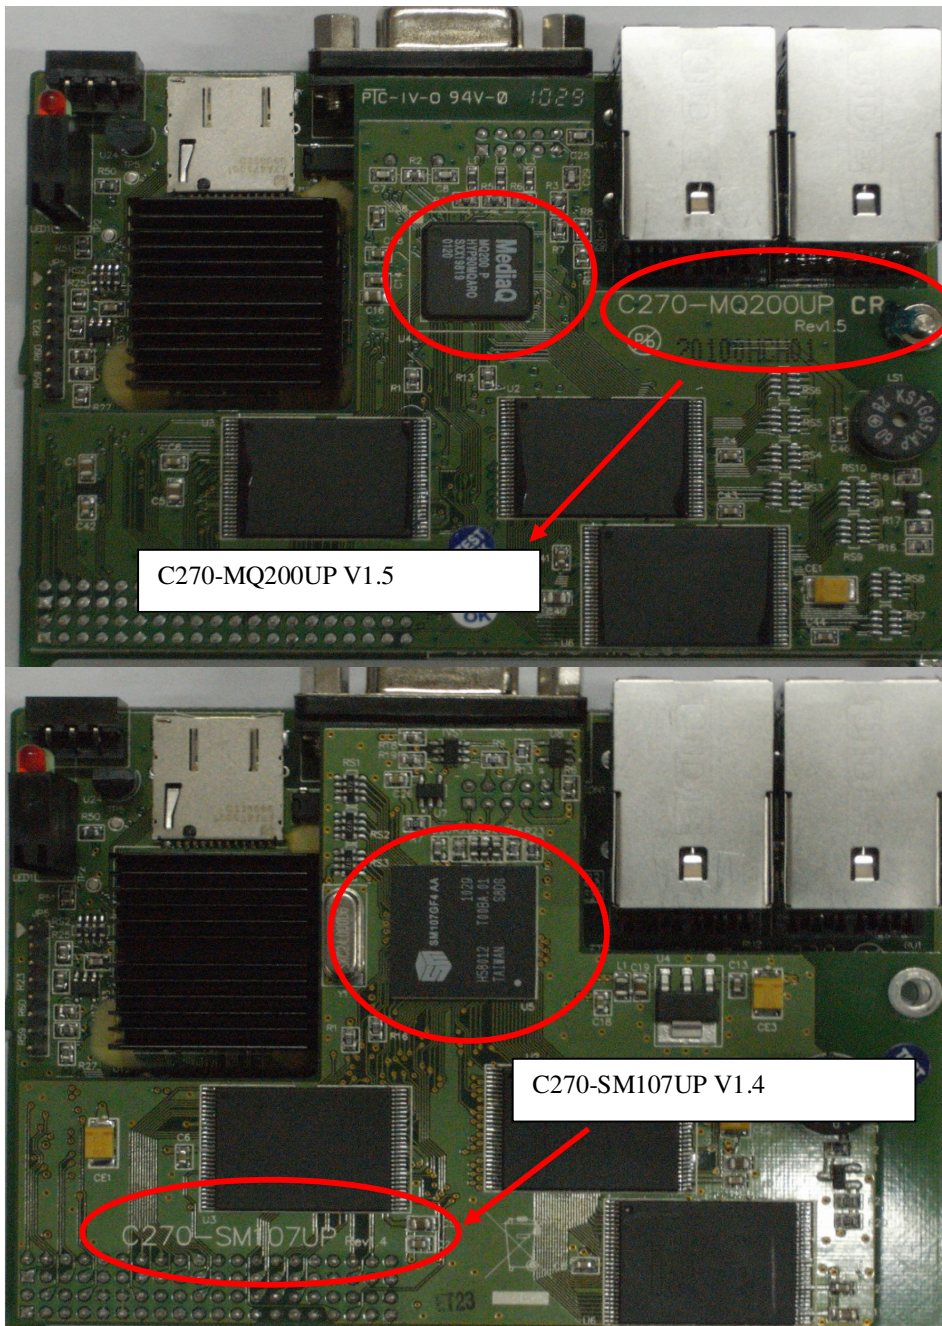
How to know the type of the Flash chips?
Visual Method

The MQ200 VGA chip was phased out, WP-8x3x replaces it with a SM107GF4 VGA chip since 2011, April, 6th. But the new VGA chip is not 100% compatible to the original one. Thus the OS and Eboot for WP-8x3x must be updated to version 1.2.0.3 and 1.2.1.0 to support both version of the VGA chip.

And please note, the older versions of OS and Eboot don't work on the WP-8x3x that is equipped with the SM107GF4 VGA chips. Don't install the earlier OS and Eboot to it, else it will not boot.

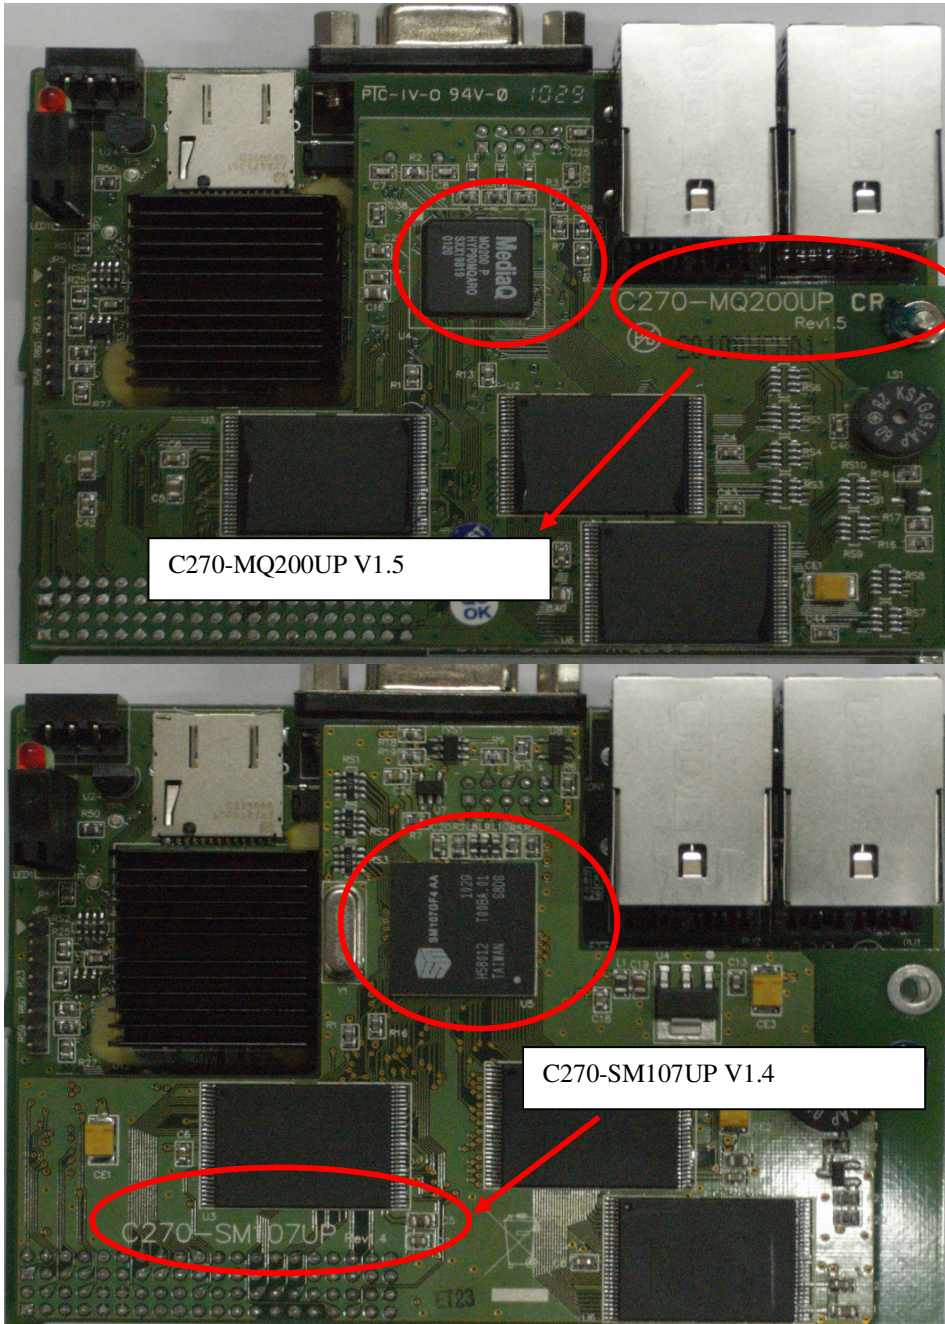
如何辨識新、舊版的 Flash Chip ?
肉眼判斷

MQ200 VGA Chip 已經停產，WP-8x3x 從 2011 年 4 月 6 日起，將使用另一個 SM107GF4 VGA Chip 進行取代。但是這個新的 VGA Chip 和原來的並不是 100% 相容，因此，必需將 OS 及 Eboot 更新到 1.2.0.3 及 1.2.1.0 版，以同時支援這兩種 VGA Chip。

但是必需注意的是，舊版的 OS (1.2.0.1)及 Eboot (1.2.0.5)在配備新版 VGA Chip 的 WP-8x3x 上將無法正常運作。請勿將舊版 Eboot 及 OS 安裝到配備新的 VGA Chip 的 WP-8x3x 上，以免造成無法開機的問題。
